Performance of Uncoated AFRSI Blankets during Multiple Space Shuttle Flights

Paul M. Sawko and Howard E. Goldstein

April 1992

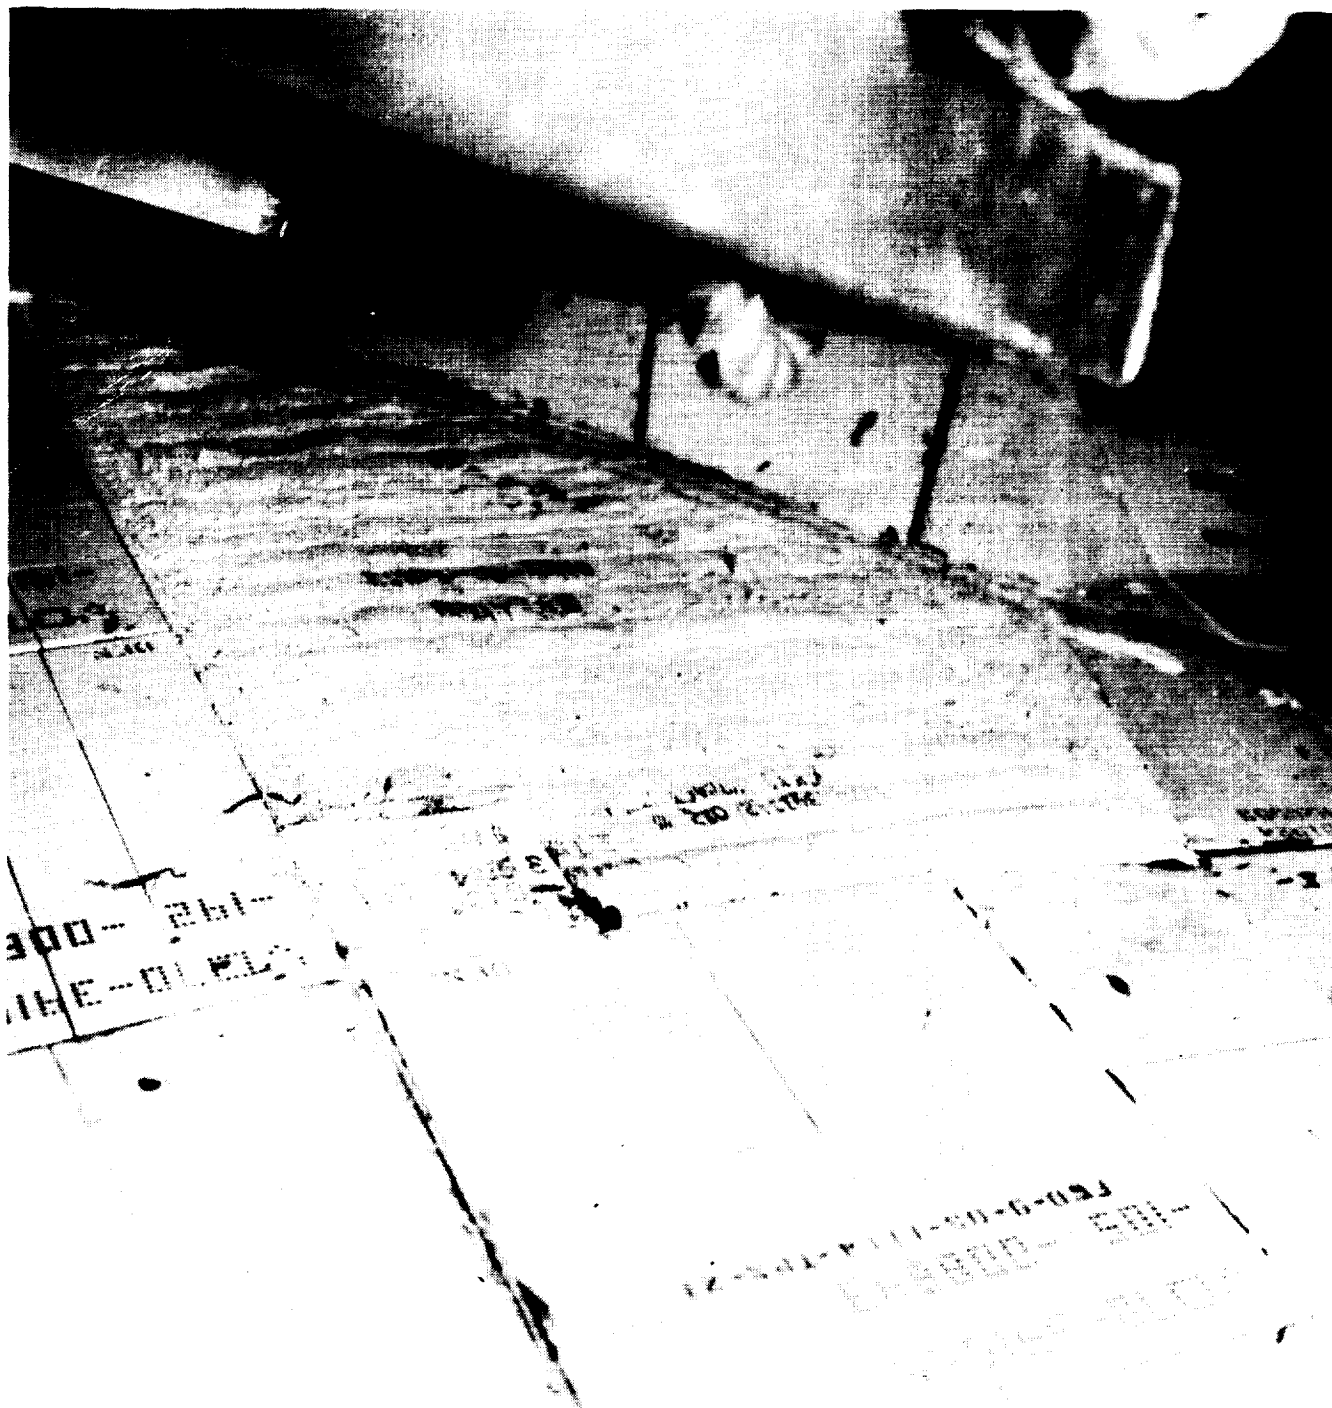
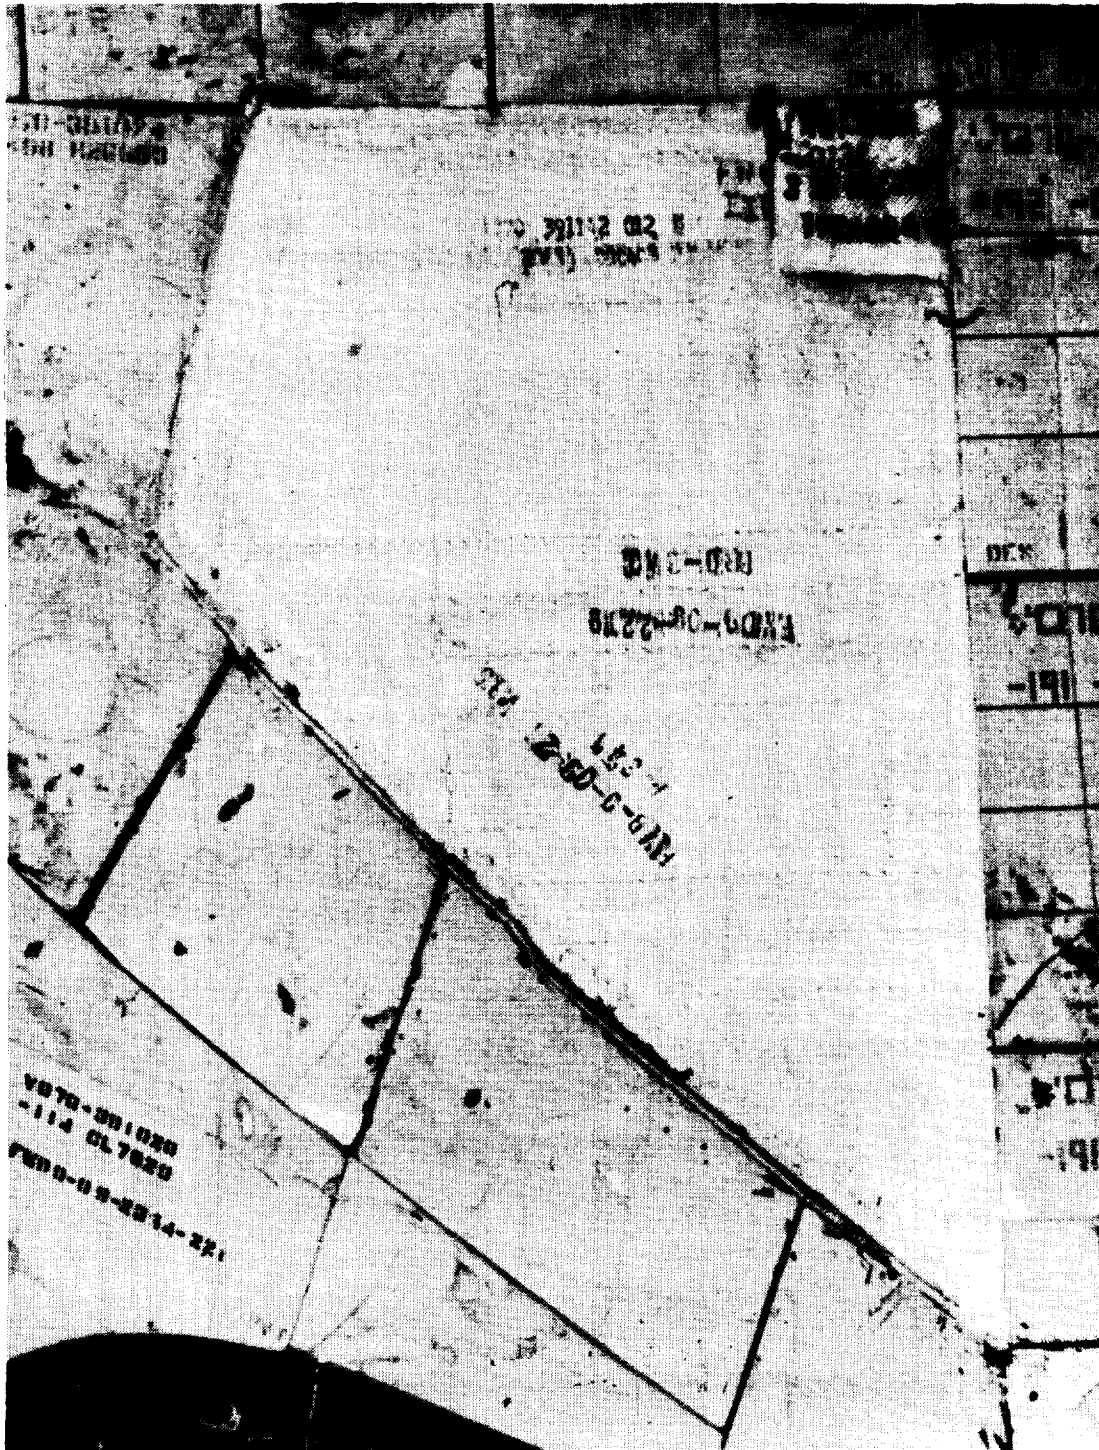
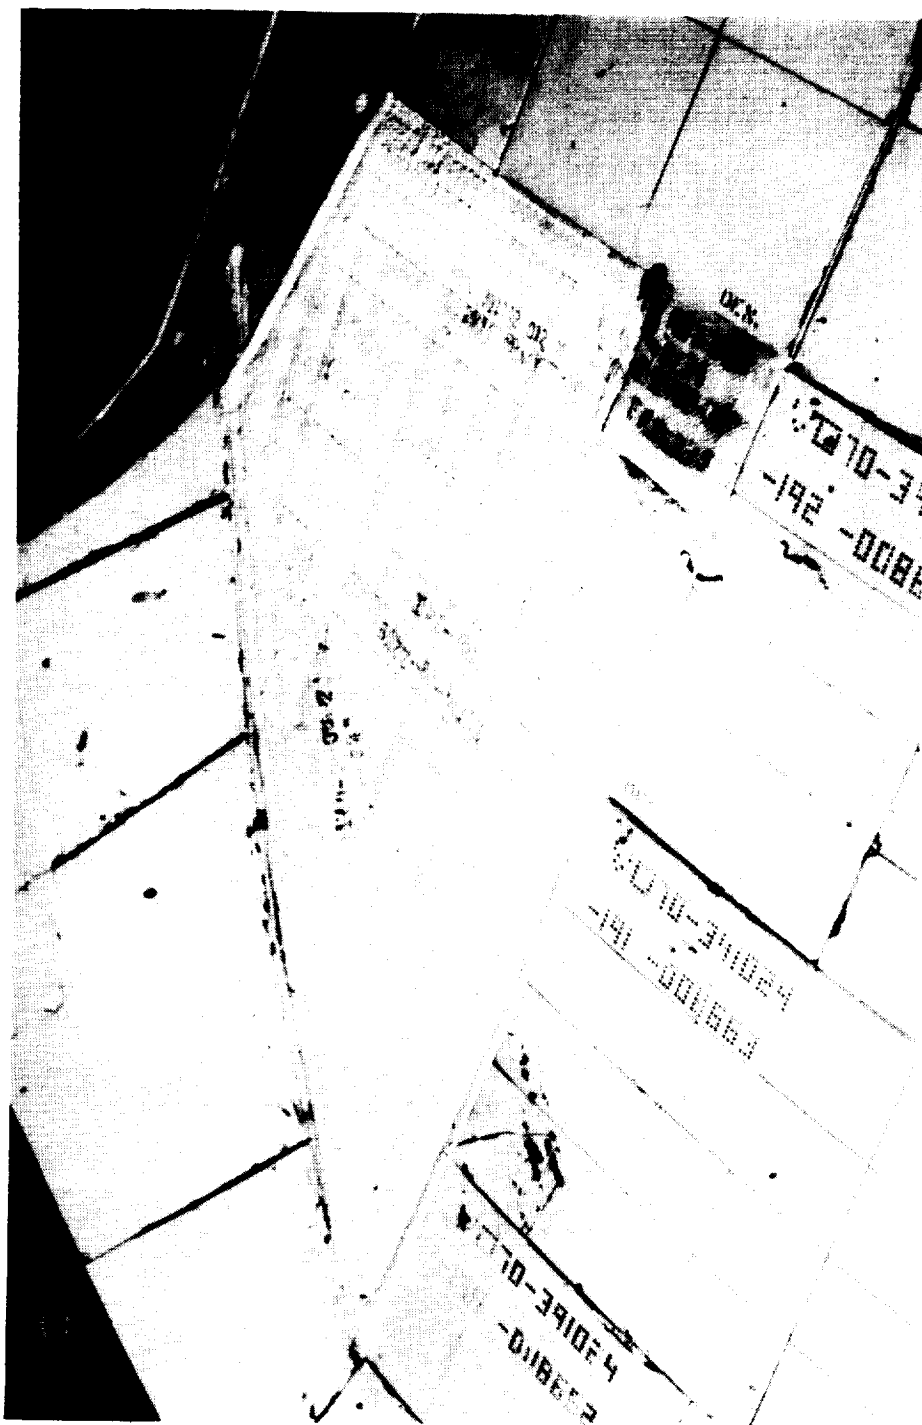
Figure 3. Forward windshield location, Flight 61A.

No data were recorded for STS-8, but postflight visual inspection after the next flight, 41B, showed that the blanket had sustained some minor fraying of the surface fabric along the leading edge (table 3). A similar observation was noted for Flights 41C and 41G, with no further progression of fabric fraying. After 51B, some additional damage in the form of broken threads was noticed and some yellow discoloration was evident, but there was no distortion. After 51F, damage had progressed to a small area of missing fabric at the leading edge plus some torn fabric along the trailing edge. These damaged blanket sections were repaired with C-9 coating before the next flight. This is shown in the preflight photograph in figure 3(a). Flight 61A, the last completed flight in the OEX series, showed the C-9 coating repairs responding well to the thermal and acoustic environment, since no new damage was evident. The photograph in figure 3(b), taken after the landing at DFRF, demonstrates that a blanket can be repaired with C-9 coating. Figure 3(c) is a postflight photograph taken at KSC and shows no further change after the ferry flight to return Challenger to KSC. Note that the square patch in the upper right corner survived

this flight, which shows that patch repairs can be made to an individual blanket. Also, no further discoloration or surface distortion occurred.

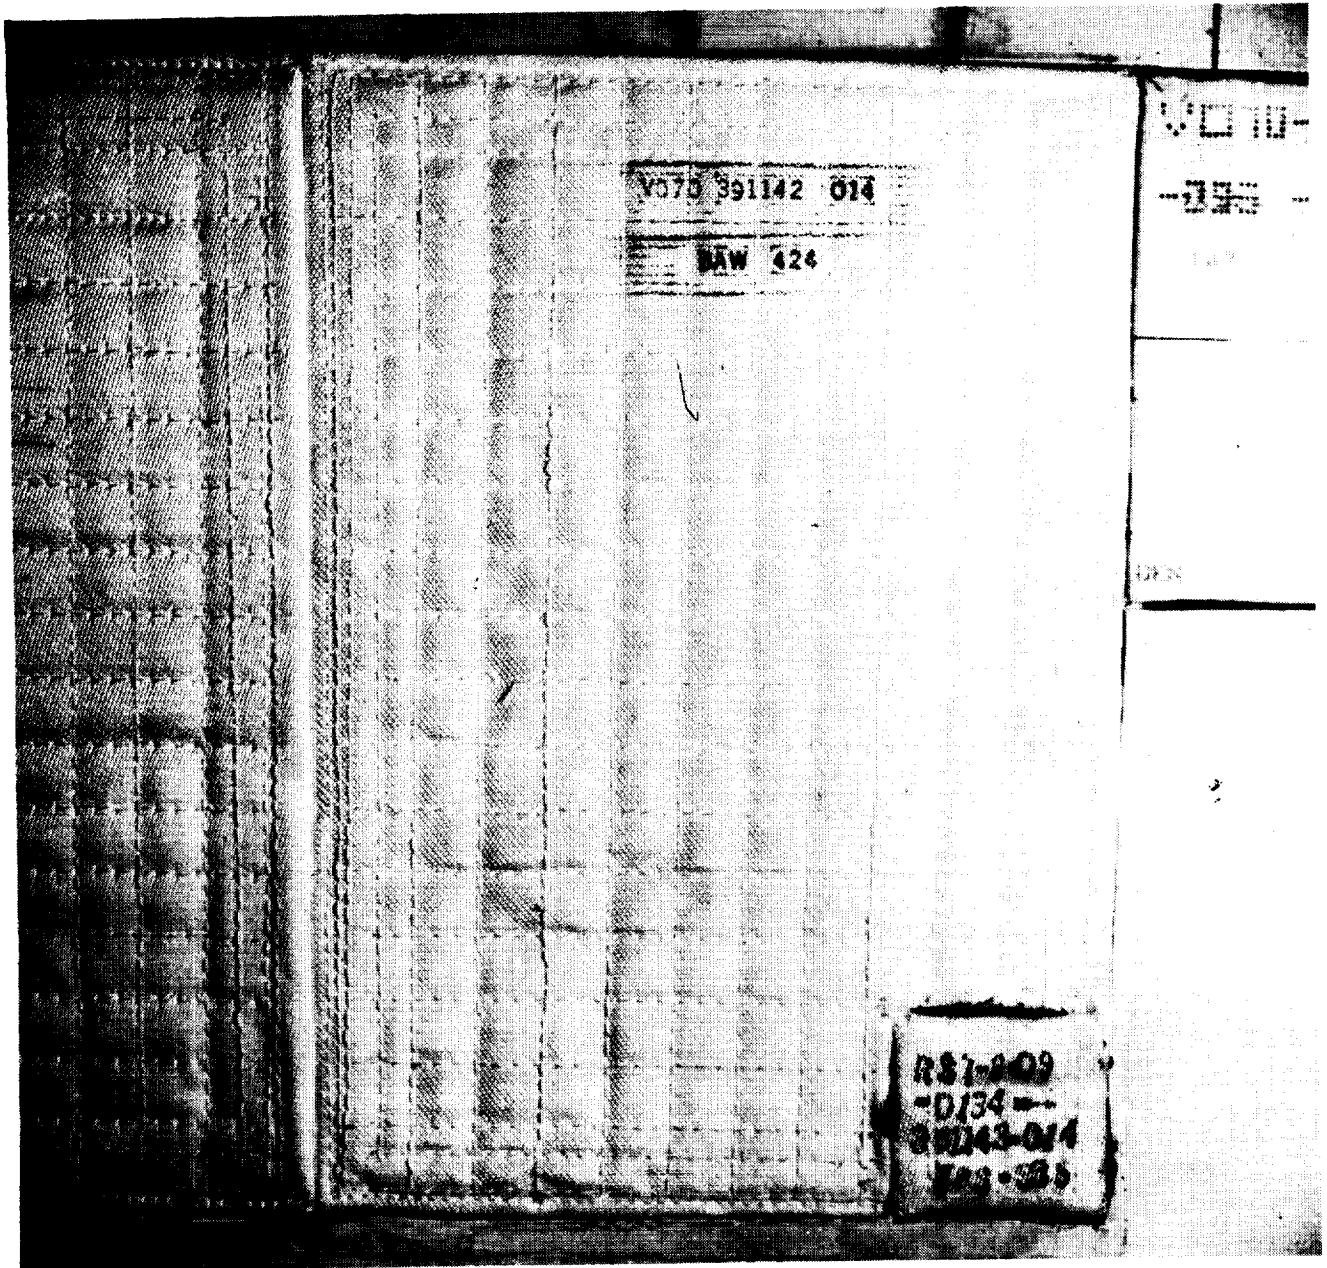
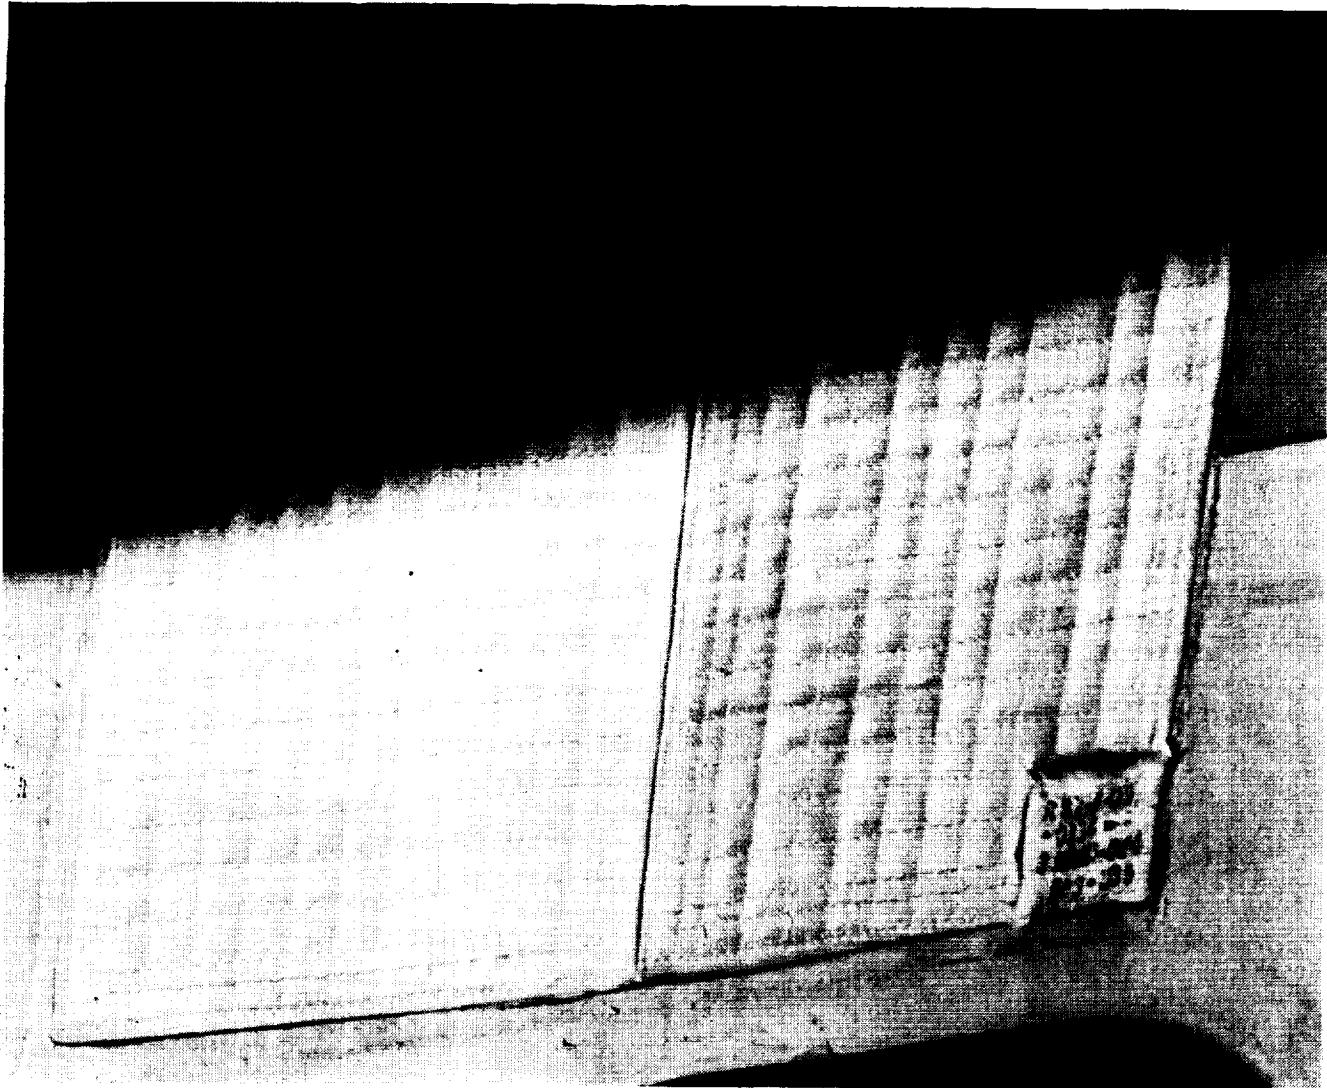
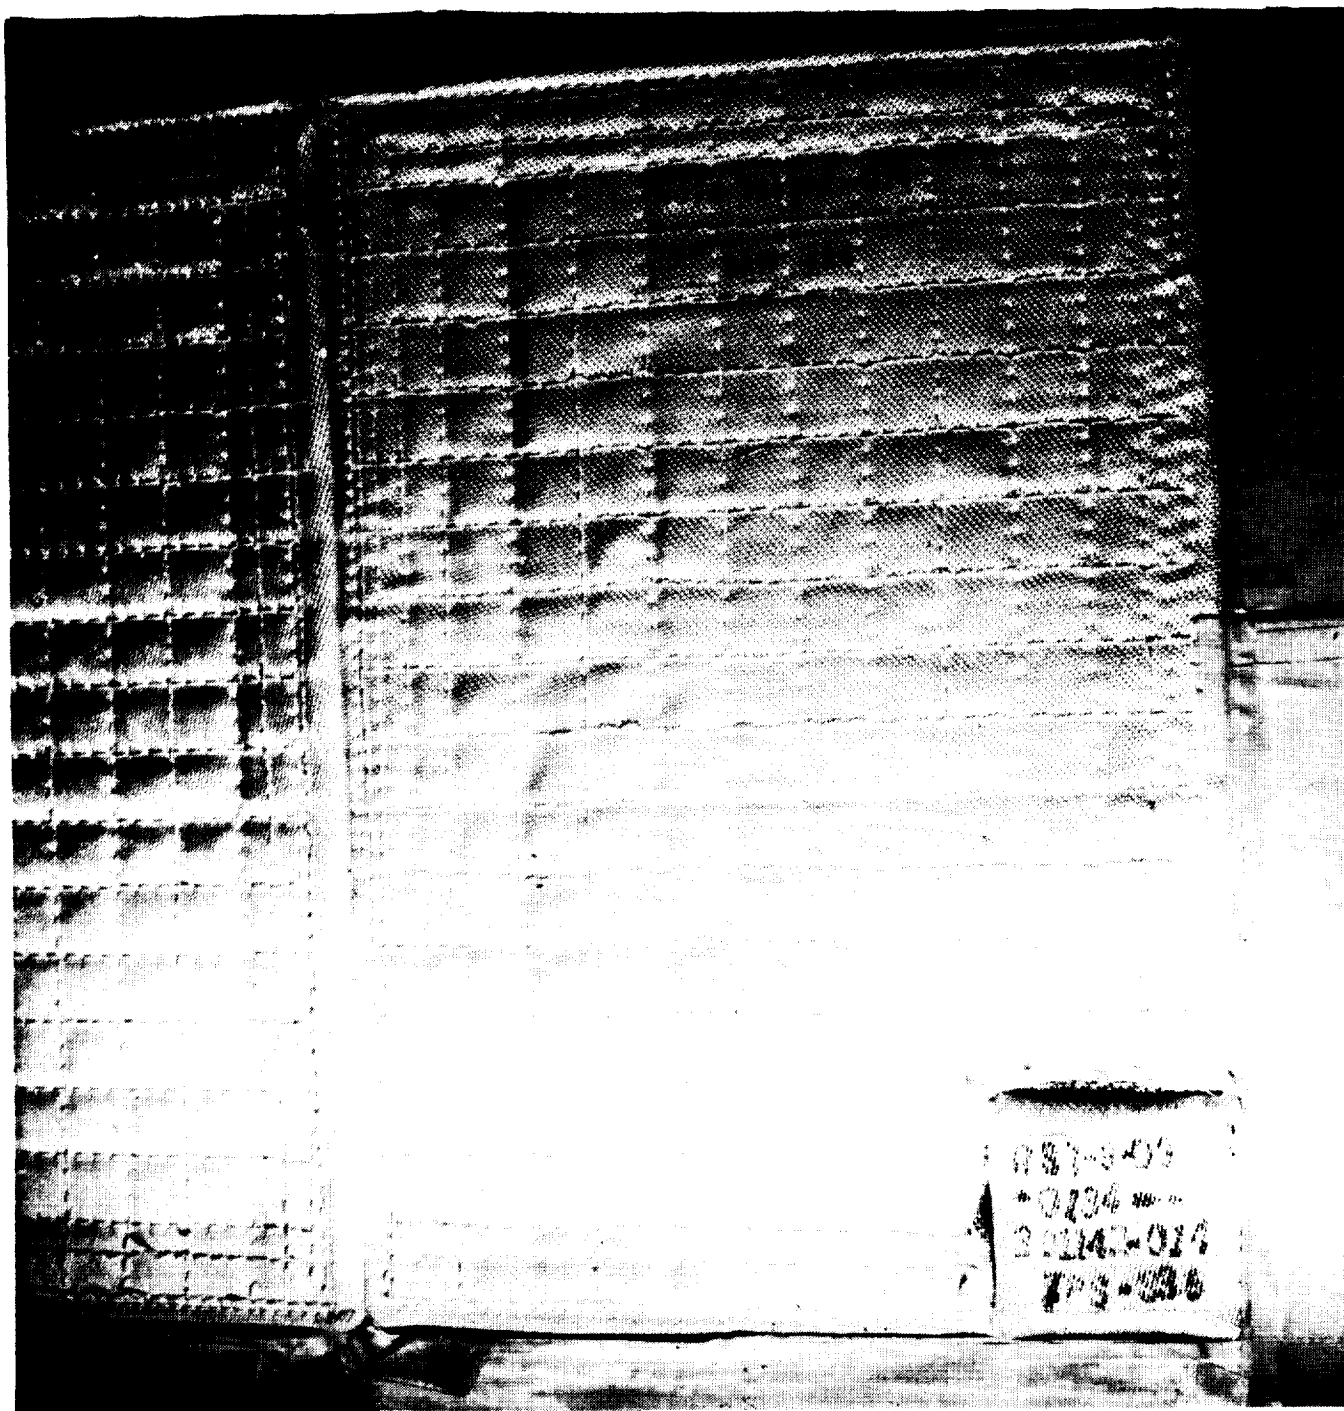
Figure 4. Forward canopy location, Flight 61A.

The overall condition of the two blankets located here was excellent after seven flights. No fabric or thread damage was observed. The only changes were a slight pillowing with insulation movement at the trailing edge, seen after Flights 51B and 51F, and some minor discoloration of both blankets from the red silicone adhesive (RTV 560) used to attach the blankets. The photographic record of Flight 61A supports these observations. Figure 4(a) is the preflight and figure 4(b), the postflight photograph taken at DFRF; figure 4(c) is the final postflight photograph taken at KSC after the return ferry flight via the modified Boeing 747 aircraft. This location is exposed to the highest peak acoustic levels, during both ascent and reentry, of any of the eight locations (see table 1).

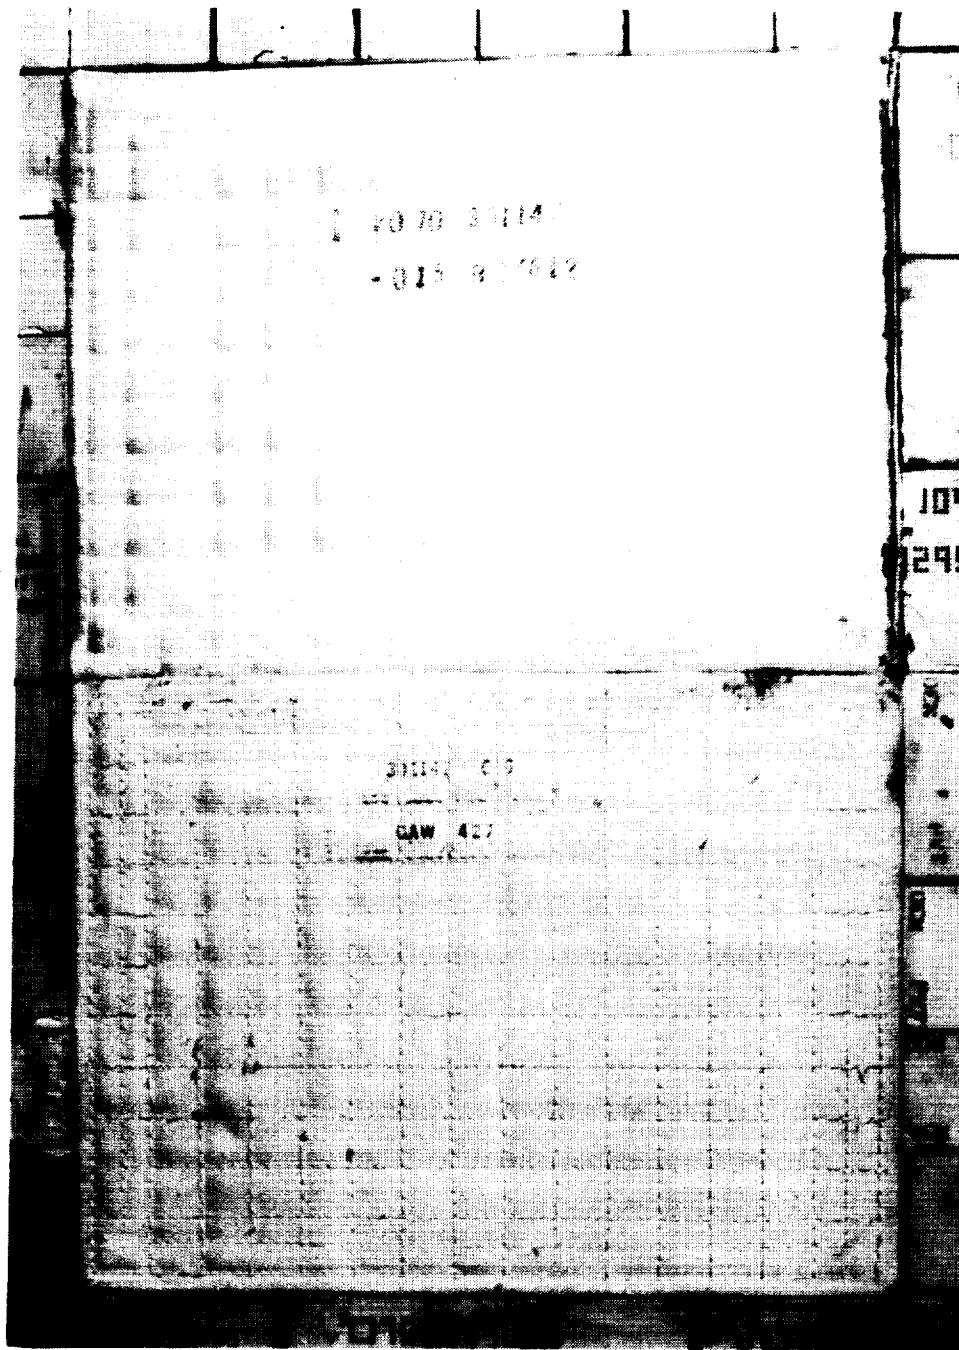
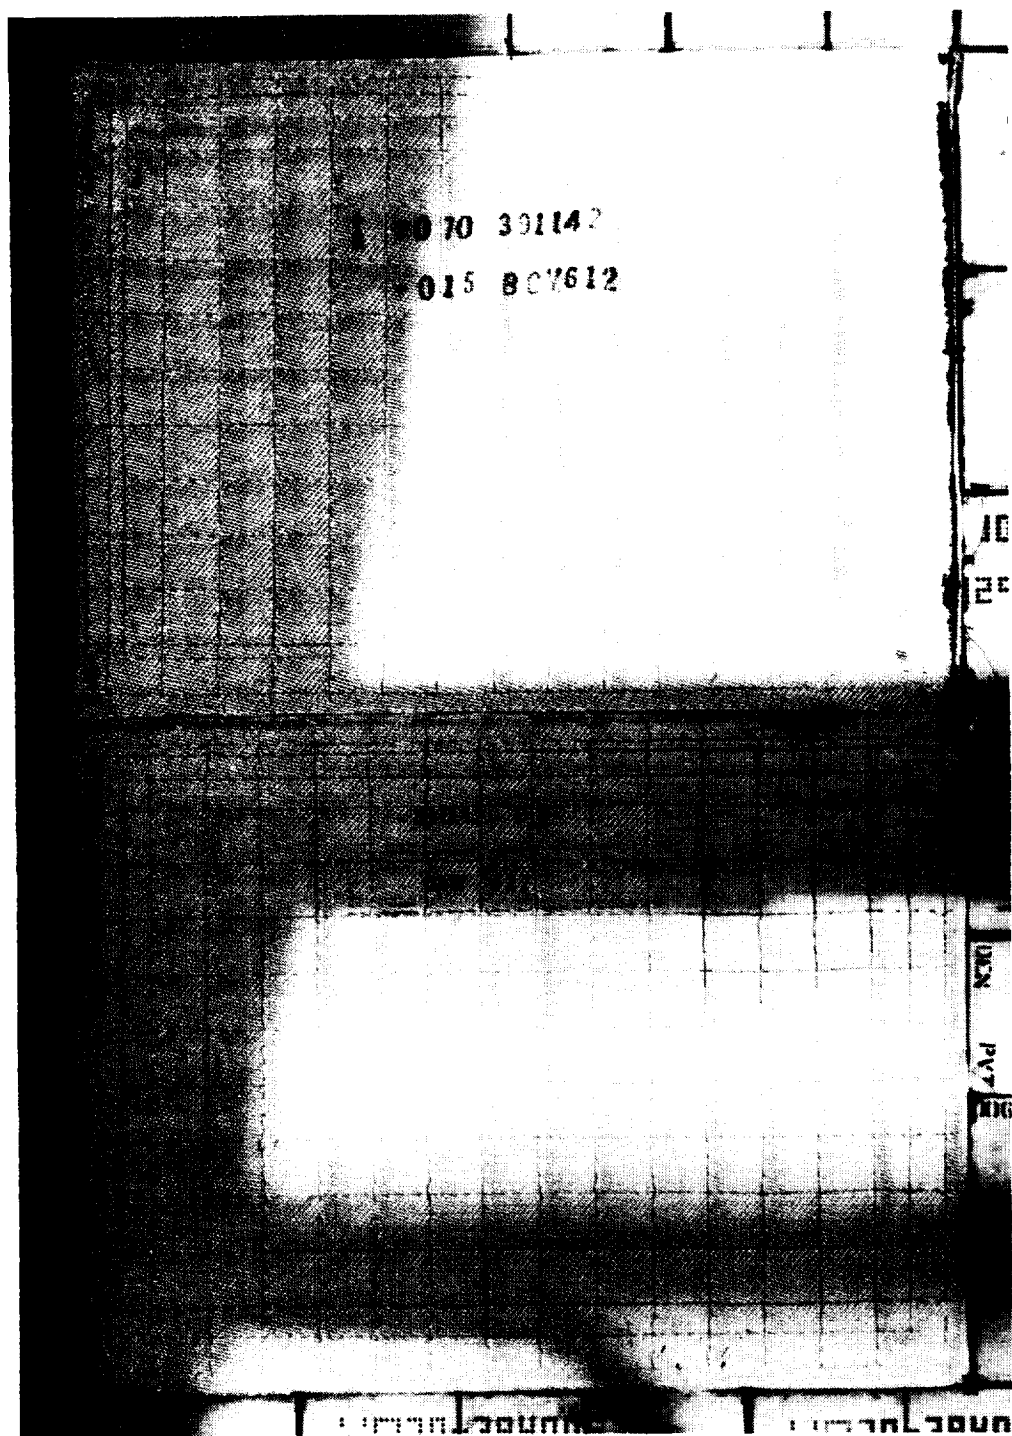
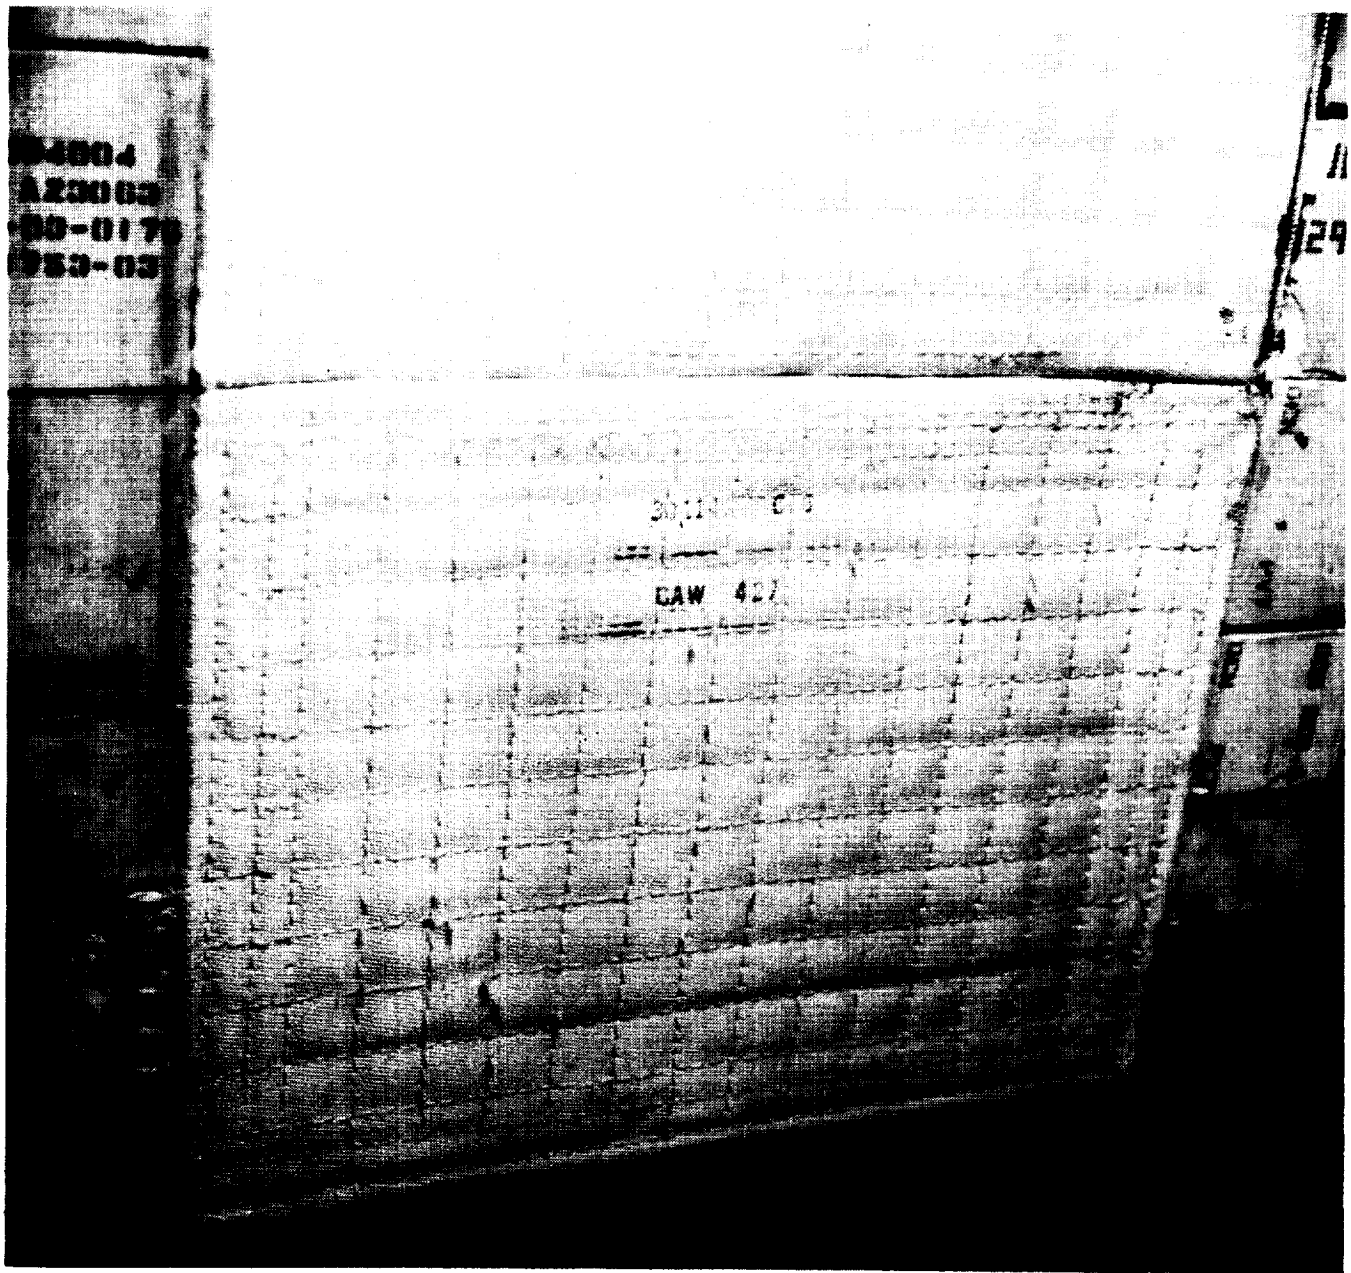
Figure 5. Forward mid-fuselage location, Flight 61A.

Visual inspection of the newly installed Blanket 391142-015 after Flight 61A showed fabric damage in the form of an abraded surface in the center of the blanket, as well as some loose stitches. The adjacent blanket also had an

abraded fabric surface and broken threads, indicating that minor wind erosion had occurred. This is shown in the postflight photographs in figure 5(a), taken after the landing at DFRF, and figure 5(b), taken after the ferry flight return to KSC. A preflight photograph, figure 5(c), is provided for comparison. The blankets were left unrepaired to permit continued evaluation.

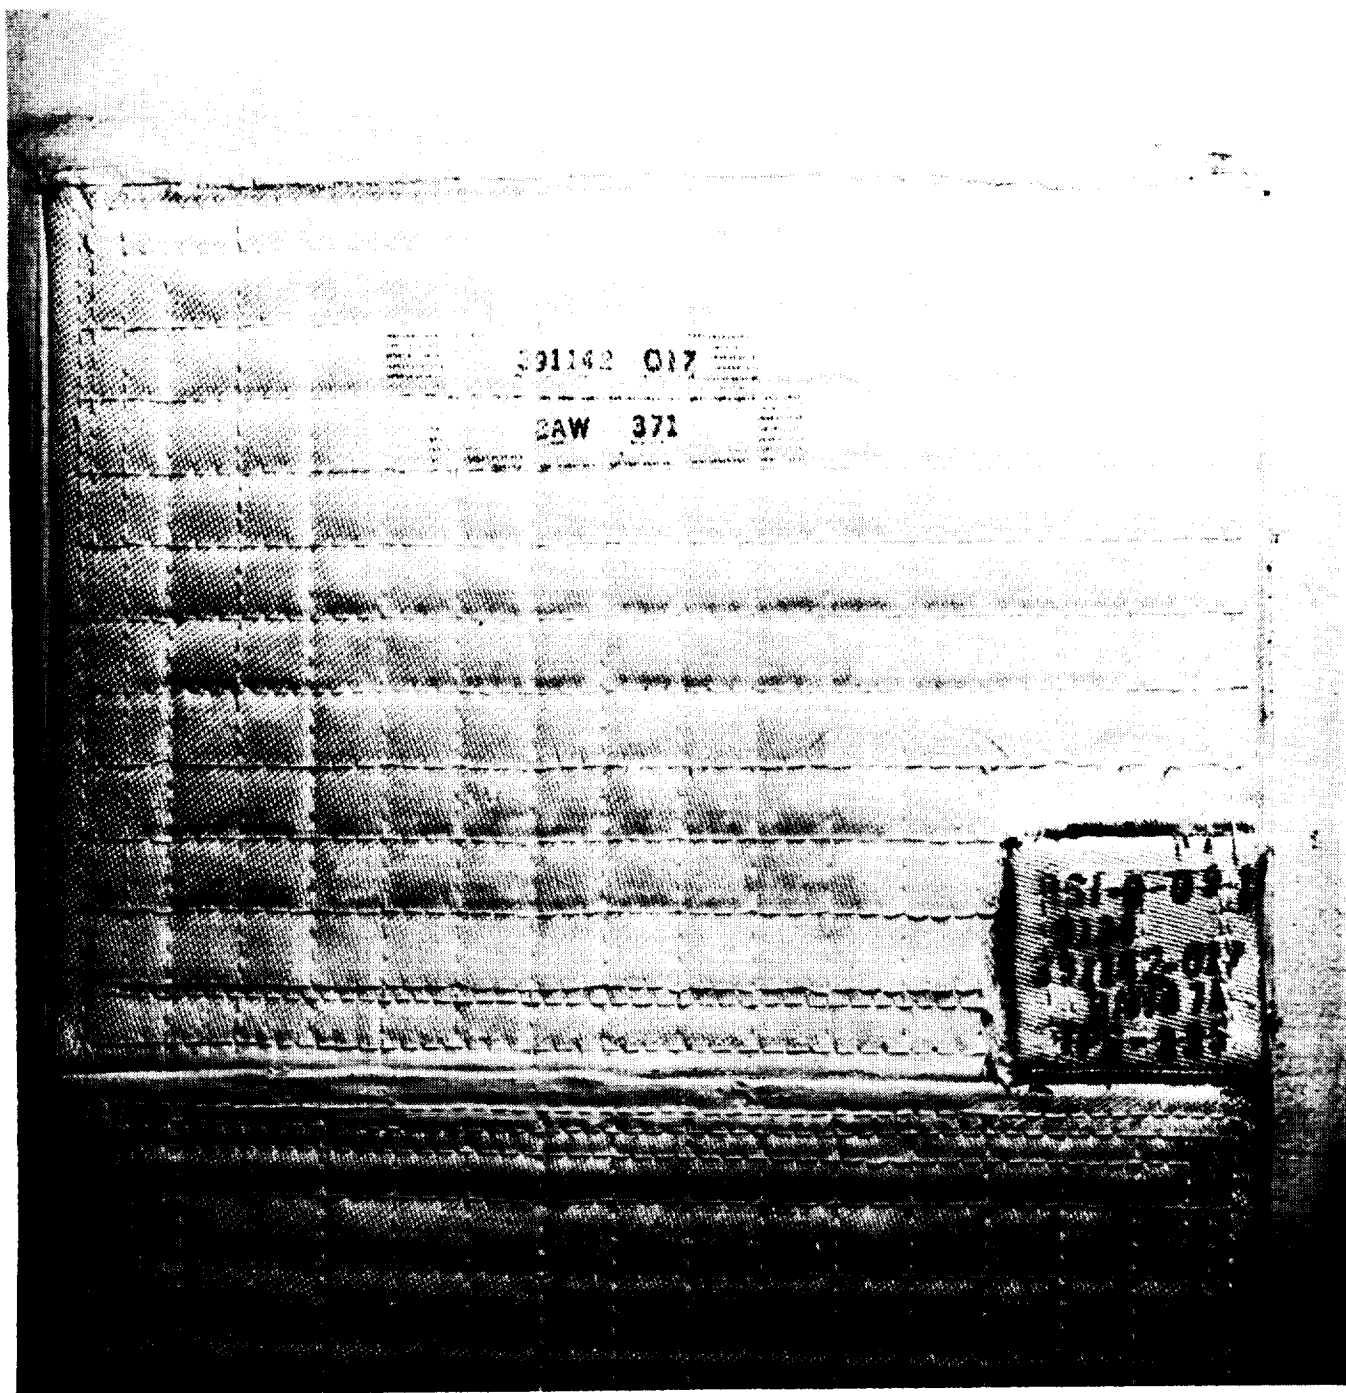
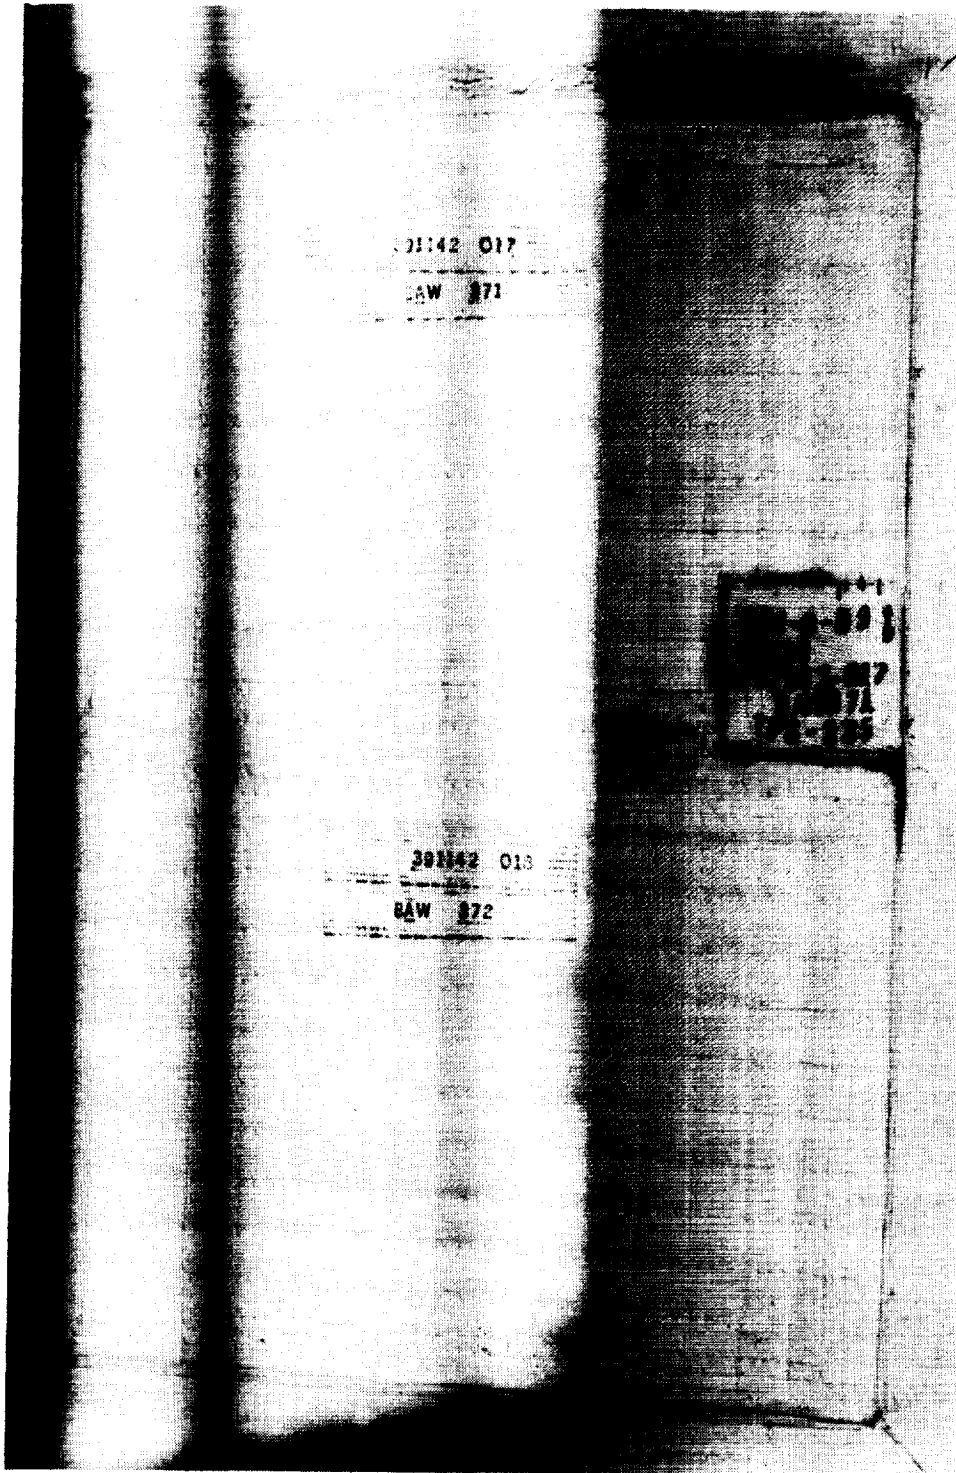
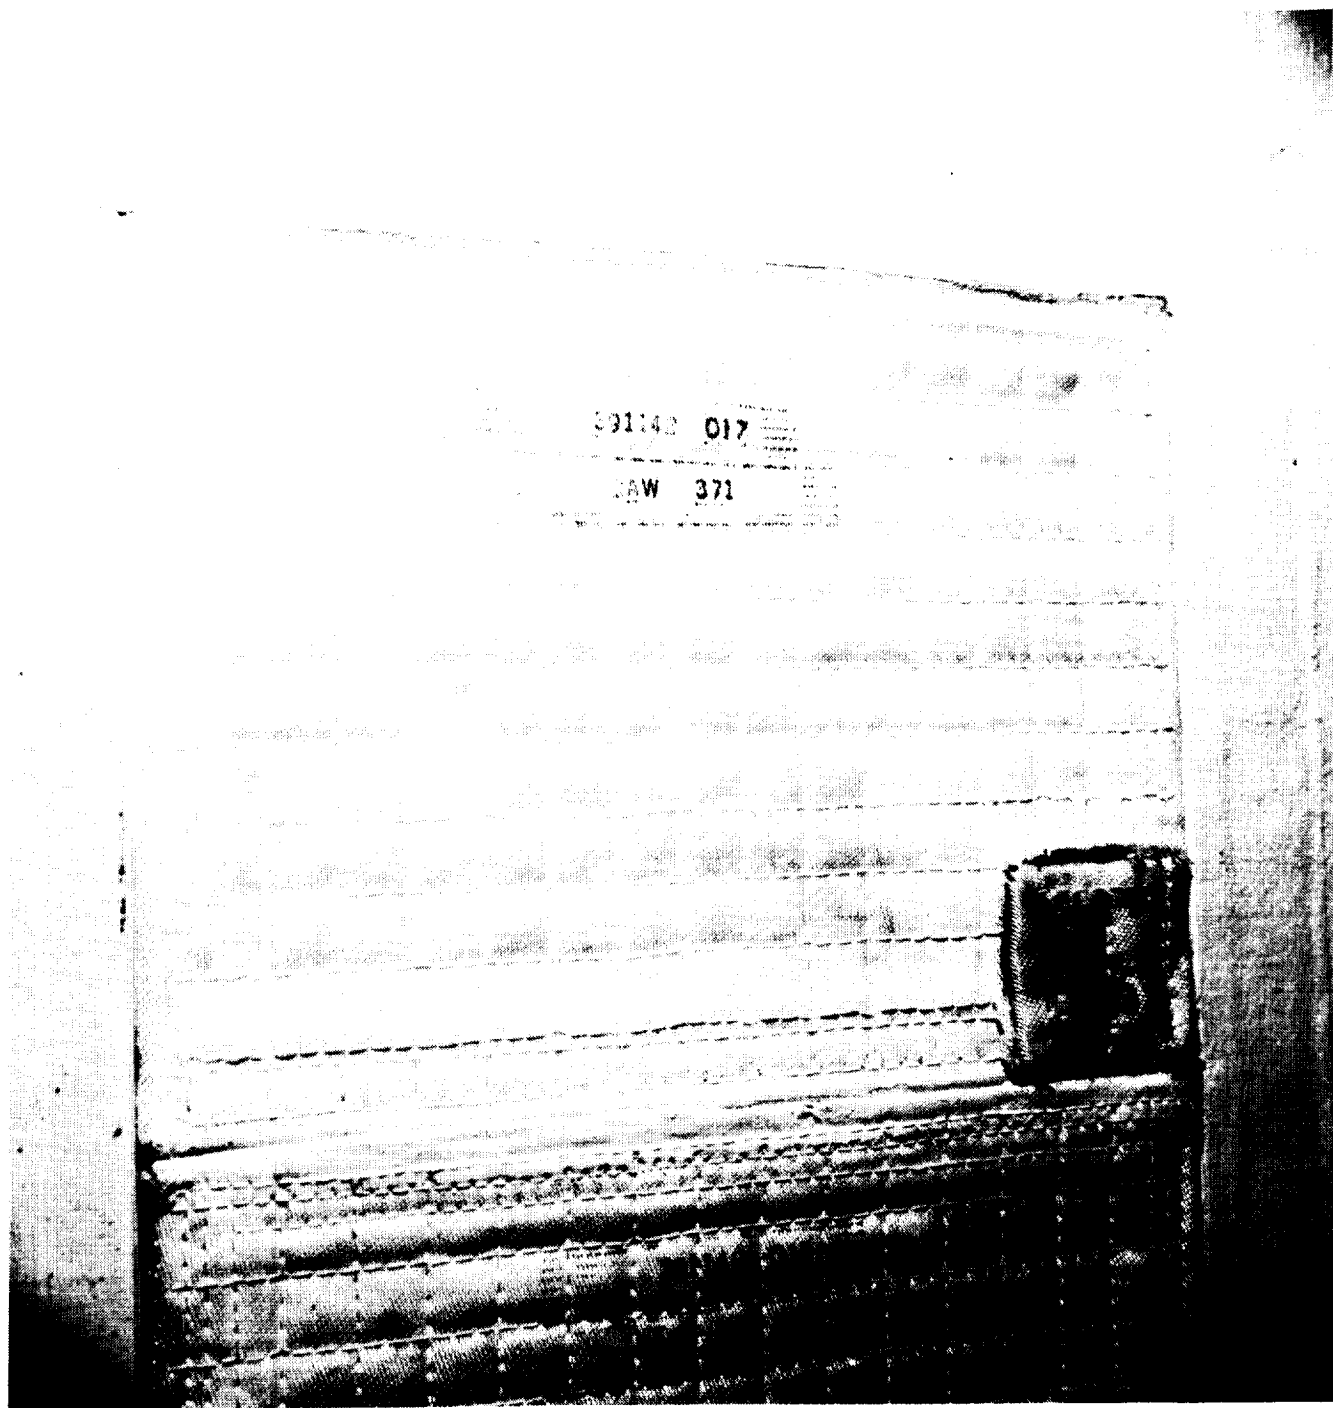
Figure 6. Mid-fuselage location, Flight 61A.

The photographic evidence supports these observations. Figure 6(a), the preflight photograph, and figure 6(b), the postflight photograph, appear similar, with a few broken threads near the patched section. Furthermore, no observable damage occurred during the return ferry flight to KSC from DFRF (fig. 6(c)). Overall, the blanket performance in the mid-fuselage location can be considered excellent since no progressive damage occurred. The peak acoustic levels (table 2) reached in this location, the lowest for the eight locations studied, combined with the modest surface temperatures shown in table 1, contribute to a benign aerodynamic environment for these uncoated AFRSI blankets.

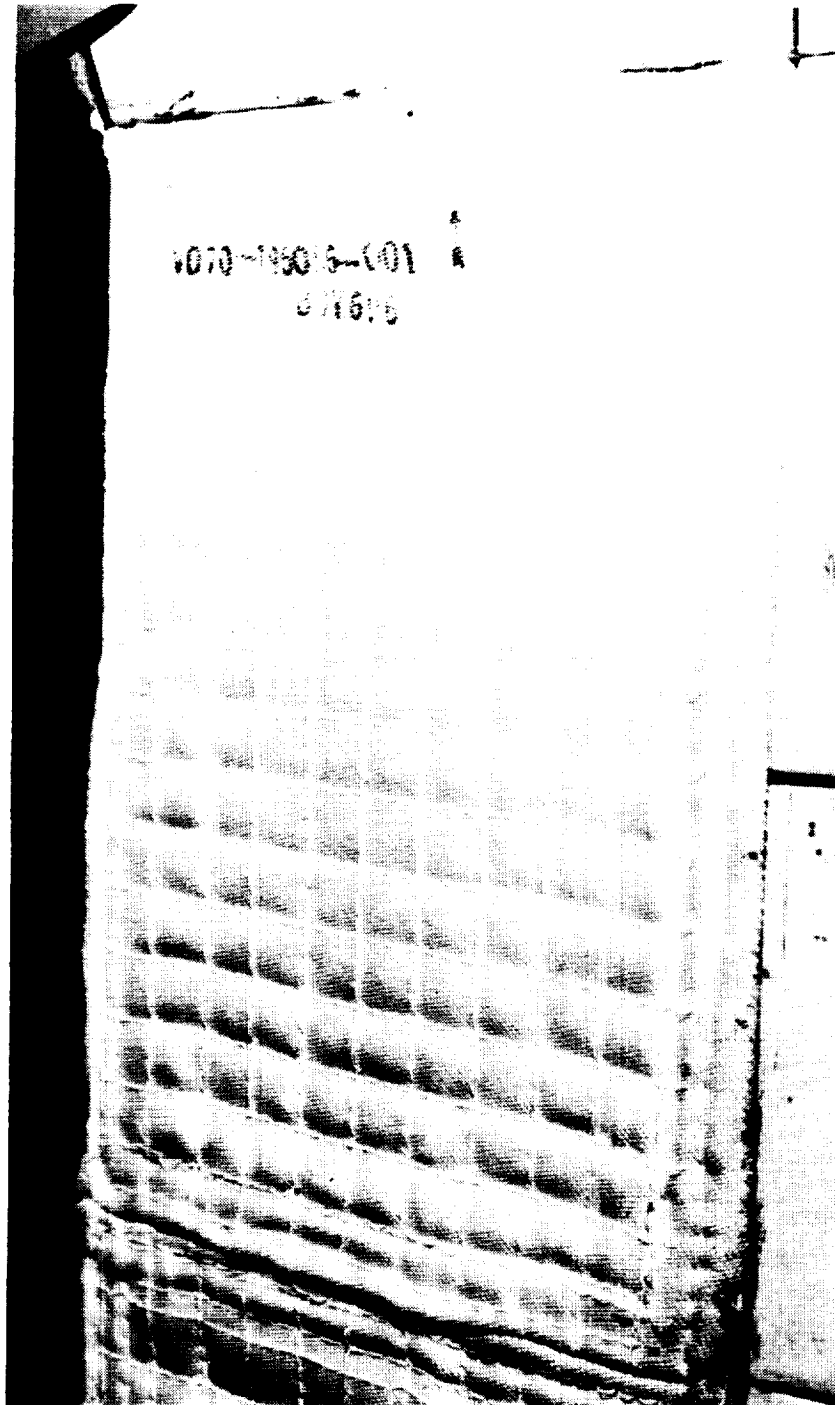
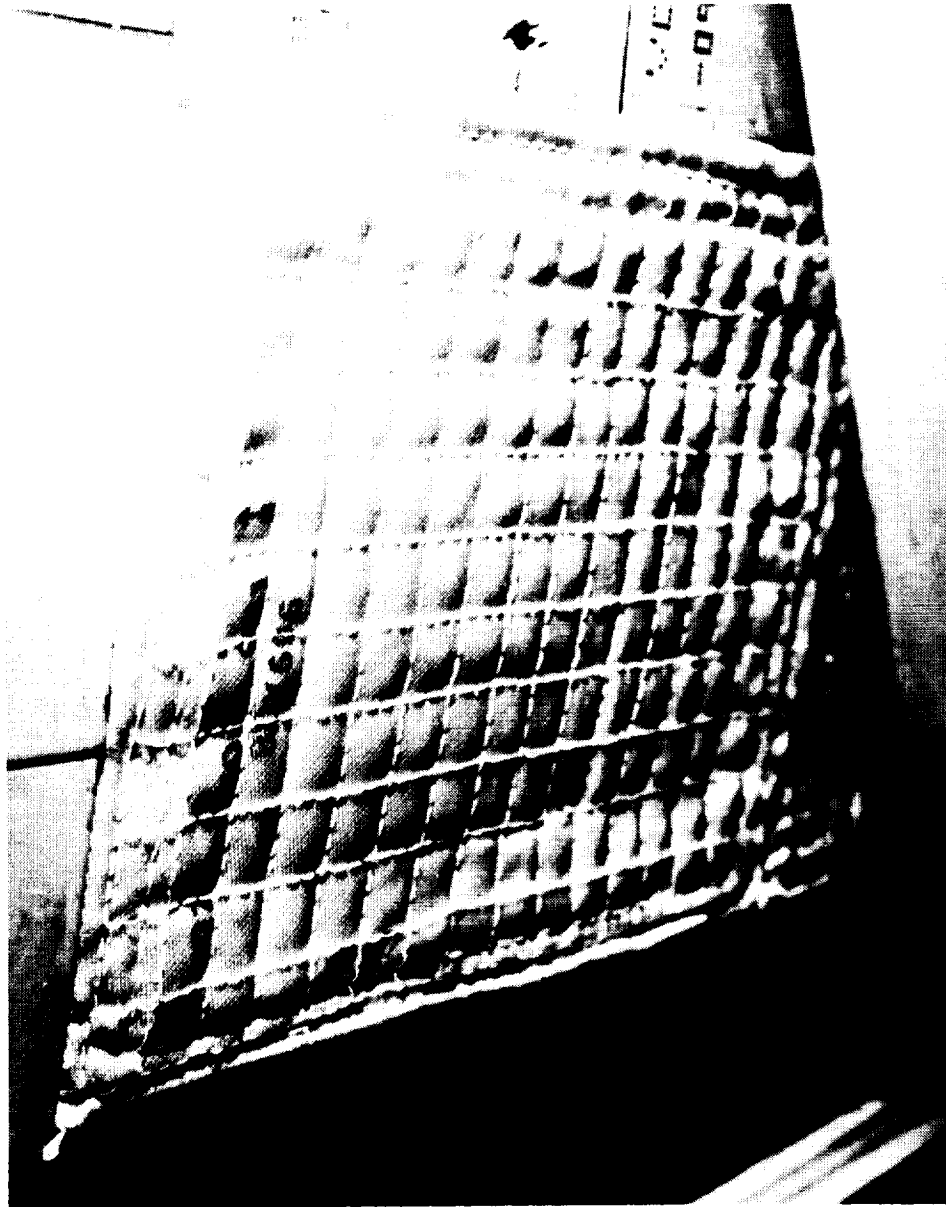
Figure 7. Upper wing location, Flight 61A.

The postflight inspection of Flight 61A, as expected, revealed no damage, discoloration, or distortion. This is documented by the preflight and postflight photographs of the AFRSI blankets on the upper wing (figs. 7(a) and 7(b), respectively). There was no postlanding photograph taken at DFRF for this location. It should be mentioned that this location had the highest surface temperature (about 1235° F) of any of the eight locations.
